**INSROP WORKING PAPER  
NO. 7 - 1995, I.1.7**

**Ice Flaking Tests Conducted with  
a Gas Actuator System**

Project I.1.7: Large Scale Hull Loading of First Year Ice. Phase 1.

By: Dr. Stephen J. Jones (supervisor), Dr. Robert E. Gagnon, National Research Council of Canada, Dr. Dan Masterson and Dr. Paul Spencer, Sandwell Inc.

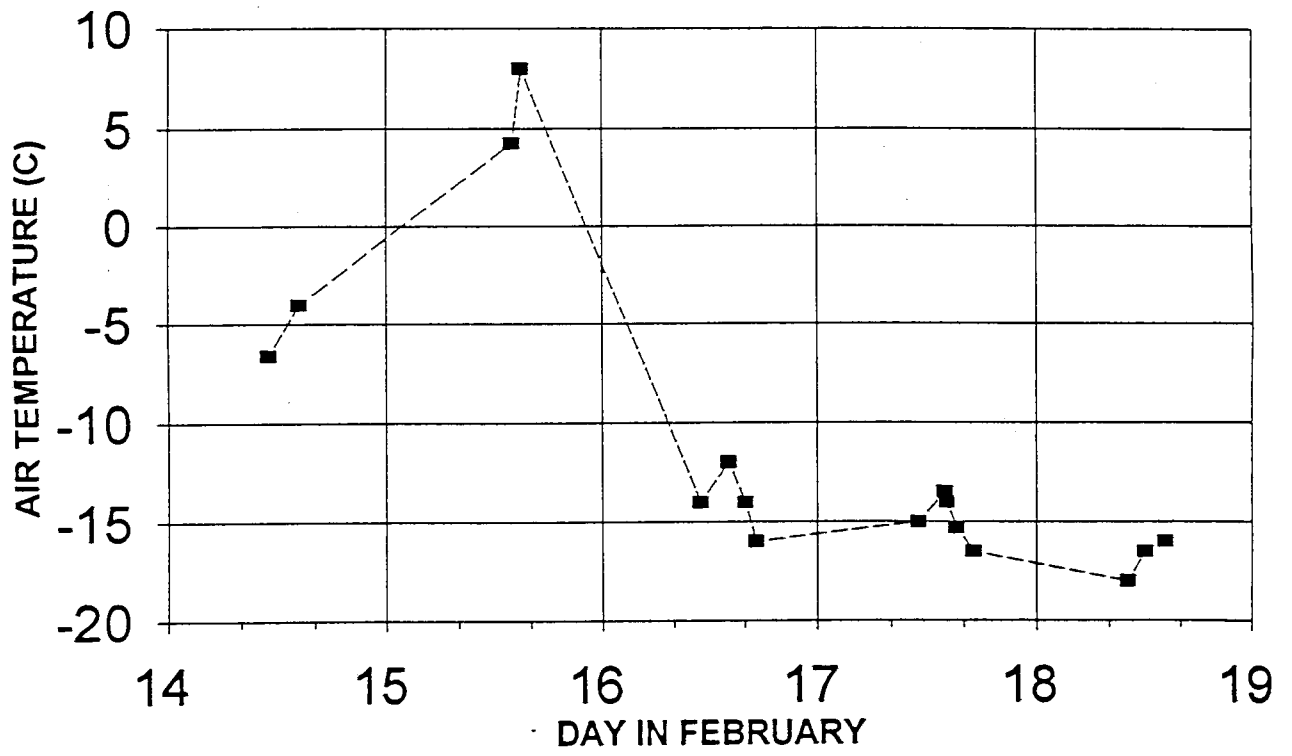
FIGURE 6.1 : AIR TEMPERATURE  
FEBRUARY 1994, STRATHMORE

The weather was excellent for conducting ice tests with air temperatures in the  $-10$  to  $-20^{\circ}\text{C}$  range, except for the 15th of February when a Chinook caused  $+8^{\circ}\text{C}$  temperatures (see Figure 6.1). The mean monthly temperature for Calgary during February is  $-7.3^{\circ}\text{C}$  and the tests were conducted during a colder than normal period. The data from the installed thermistor string are given in Figure 6.2. Note that at the thermistor string location, there was an undisturbed snow layer approximately  $0.1\text{ m}$  thick. The thermistor string was mounted in a  $50\text{ mm}$  diameter hole augered through the ice which was then packed with ice chips to reduce the freeze-in and thermal stabilization time.

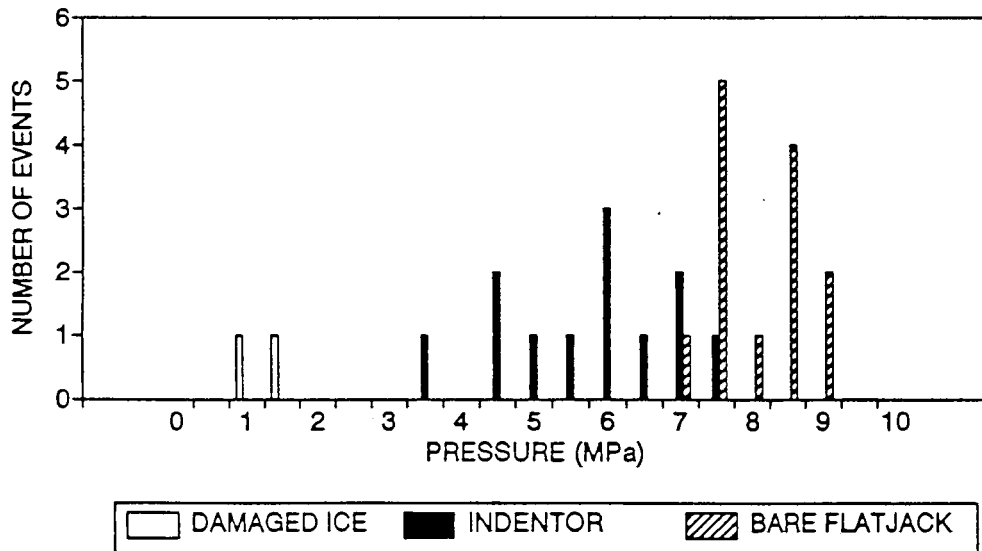
A histogram of the pressures at which cracks were detected, including the final failure, are given in Figure 8.1. Note that for the tests using a rigid indenter the governing pressures are those applied by the indenter to the ice. For tests using the bare flatjacks, the governing pressures are the effective pressures applied to the ice by the flatjack. The mean and standard deviation for the pressure for the bare flatjack tests is  $7.82 \pm 0.71$  MPa and for the indenter tests  $5.45 \pm 1.15$  MPa. As well as providing lower pressures the standard deviation for the indenter tests is larger.

FIGURE 8.1 : HISTOGRAM OF PRESSURE AT WHICH CRACKS DETECTED
