**INSROP WORKING PAPER
NO. 119 - 1998, I.5.11**

**Requirements to Environmental and
Structural Safety of Ships**

Project I.5.11: Structural Safety of Ships Operating in Ice

Title: **Requirements to Environmental and Structural Safety of Ships**

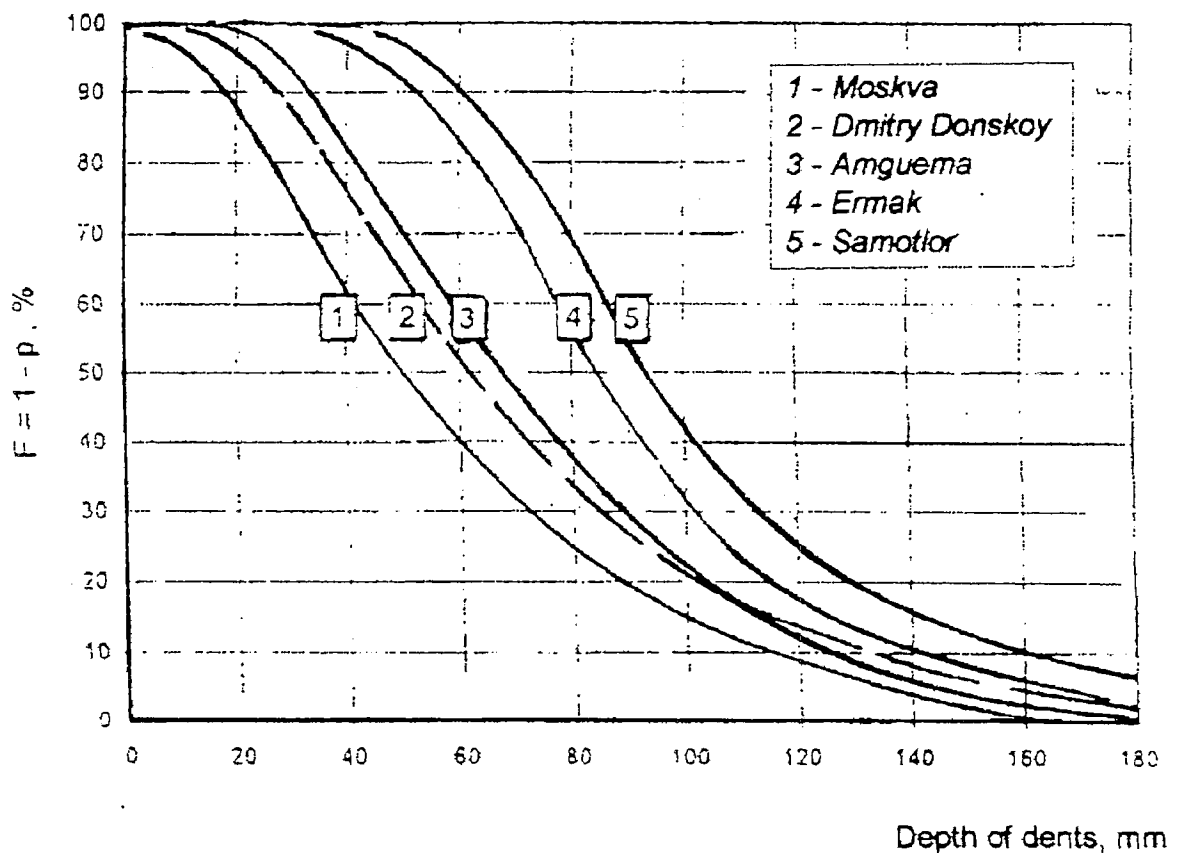
Fig. 1.5. Plots of distribution function $F = (1 - p)$ of dents depth (p - is the probability of the occurrence of dent of a given depth in the bottom and bilge strakes of the middle and intermediate hull areas)

Probability of the occurrence in a certain construction of damage in the form of a dent of definite depth (P_{if}) is presented in fig.1.5, 1.6 by the distribution function of the dent depth - $F(\geq f)$ %. While constructing the graphs the use was made of the primarily processed materials of FEPI, CNIMF and other organizations published in [1] - [3]. As the experience of the inspection for defects has shown, if dents are 80-100 mm deep and deeper, cracks are formed in the shell plating in places where the framing is welded on. As a rule, dents with such characteristics cause the water leakage. For ULA class ships, 20 - 30% of ice dents turn out in practice to have the water leakage, for L1 class ships ~ 50%.

Curves shown in figs. 1.5 and 1.6 represent probabilities of the excess by permanent framing deflections (depth of dents) of the depth of ice dents plotted on the abscissa. Under the ice damage (dent) we understand a permanent deflection of frame or of plate structure supporting the shell in the zone of the impact against ice. Fig. 1.5 shows probabilistic curves for a number of icebreakers and cargo ships. In fig. 1.6, generalized curves for ships of the UL and ULA classes being the major portion of the domestic arctic fleet are plotted.

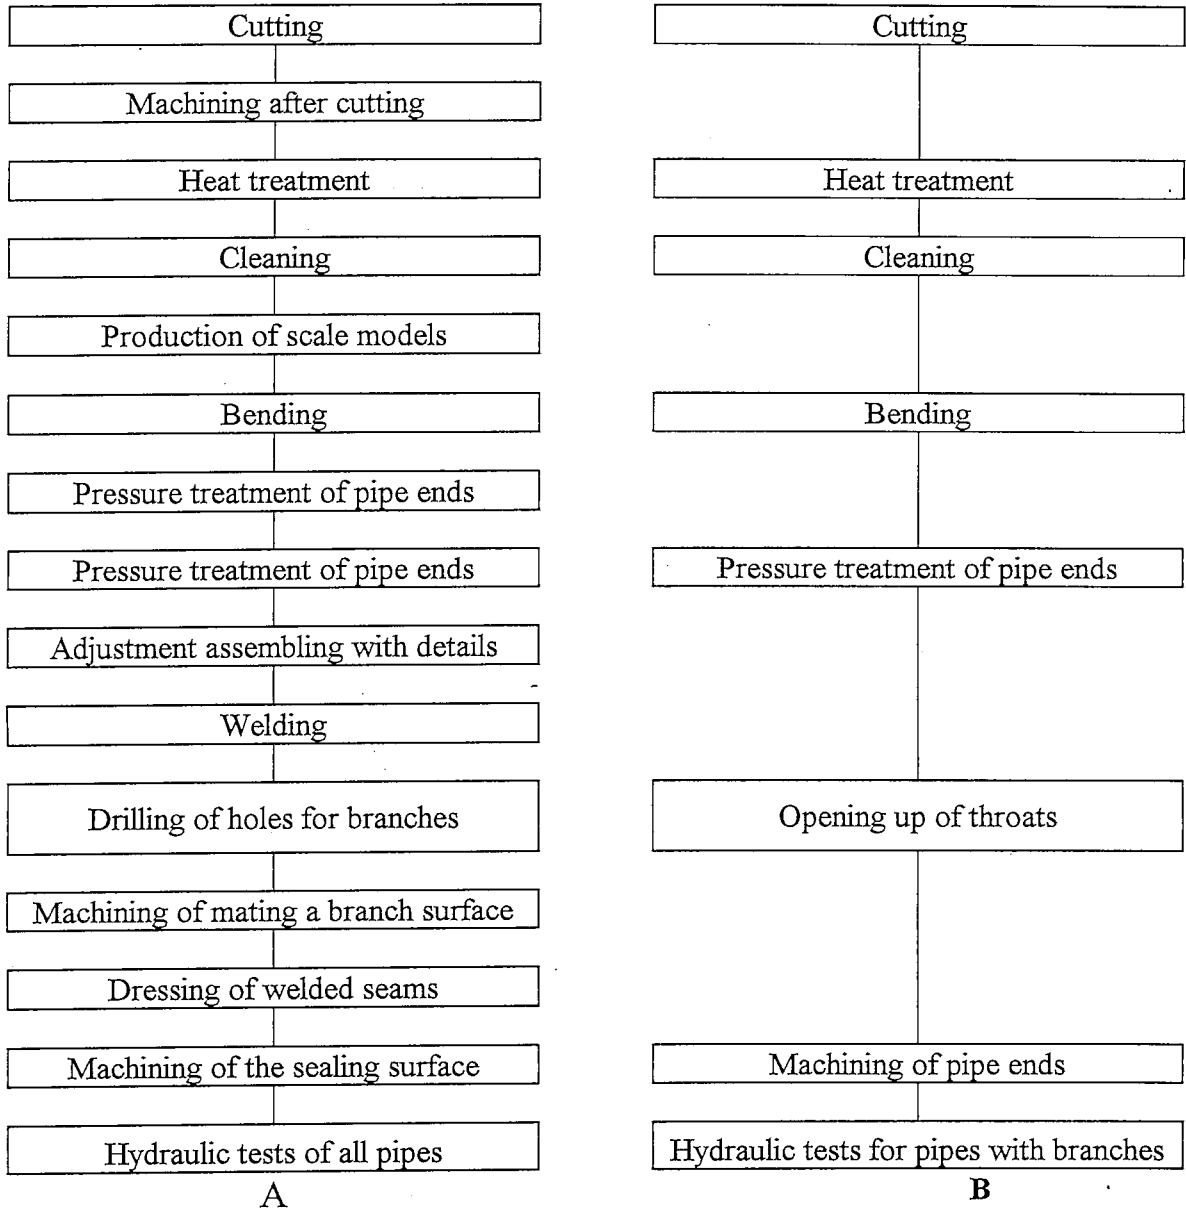
Fig.2.3. Block diagram of comparison of traditional (A) and new (B) technology of the manufacture of pipelines

Fig. 2.3 shows the comparison of the conventional technology of the fabrication of pipelines with the new one.

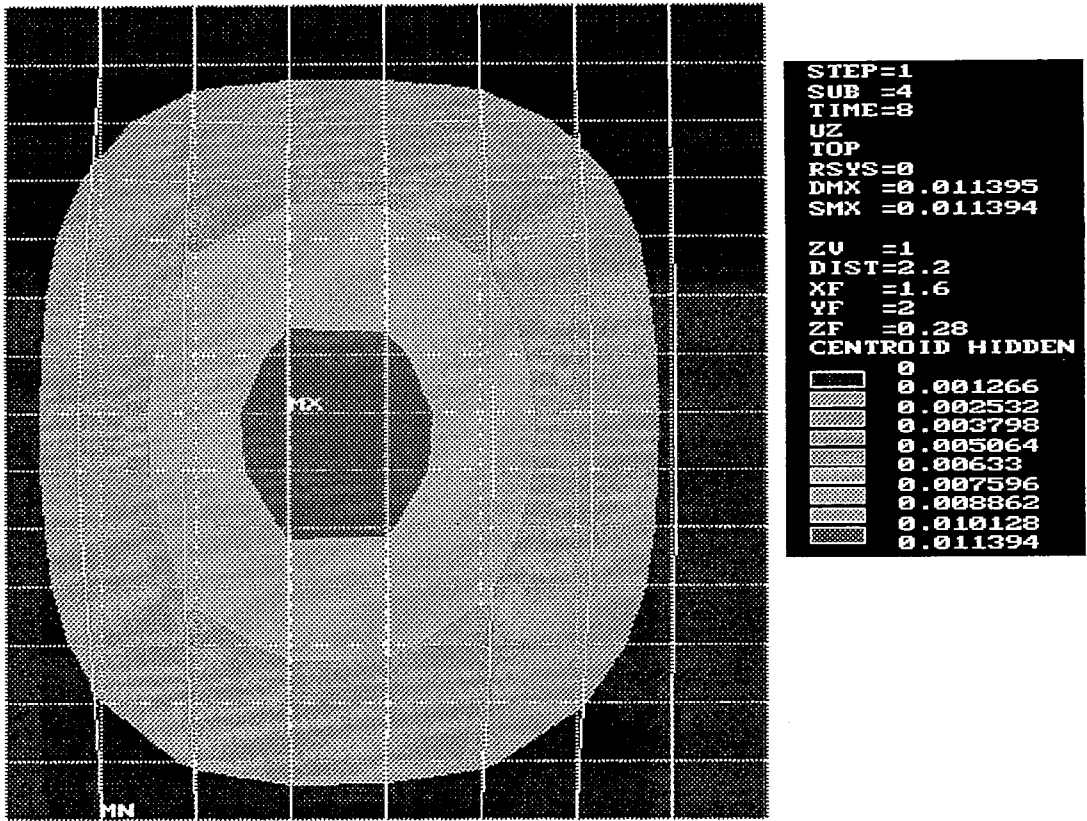
Fig.3.16. The diagram of deflection under ice pressure of 0,8 MPa

following: maximal value of the plastic deflection - 60 mm; vertical size of the damaged zone - 3,5 m; horizontal size of the damaged zone - 2,0 m. The recovery of the ice loads was carried out by the method of the stepwise loading of the structure at the following steel parameters: yield stress $\sigma_y = 300$ MPa; tensile strength $\sigma_u = 600$ MPa with $\delta = 0,2$. The results of calculation are shown in figs.3.14 – 3.17. The maximal plastic deflection as a function of the ice pressure is given in fig.3.18.

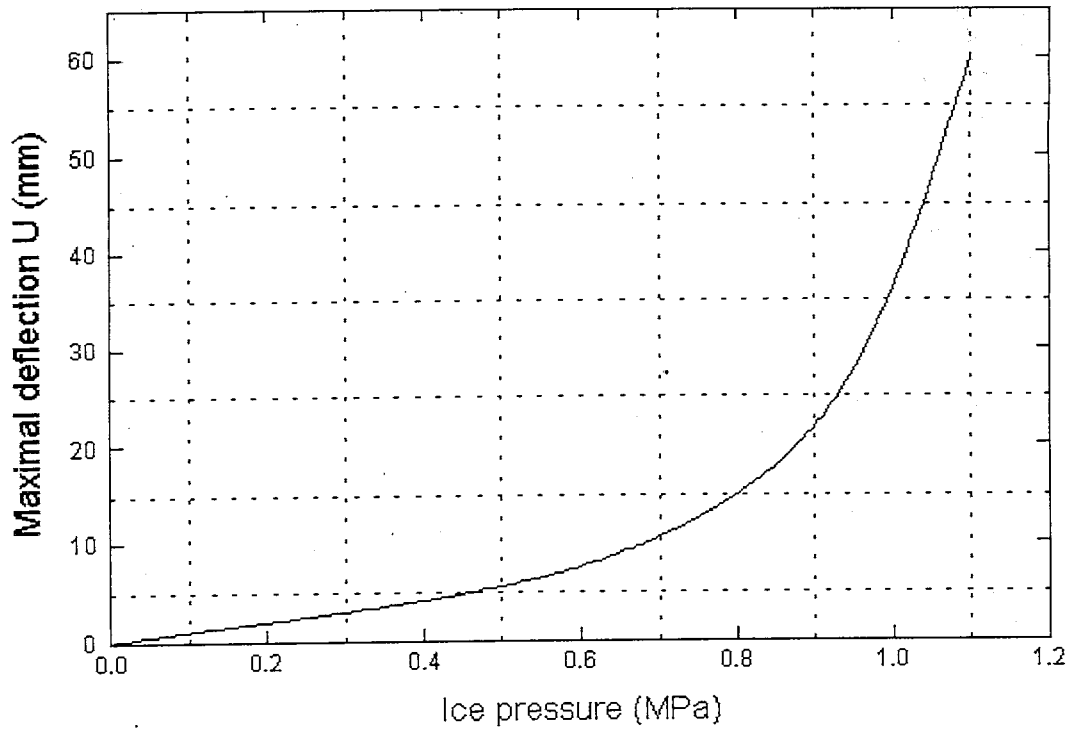
Fig.3.18. The maximal deflection versus ice pressure for the structure of fig.3.13
